GD32 and STM32 Compatibility

2. Differences and similarities between GD32 and STM32

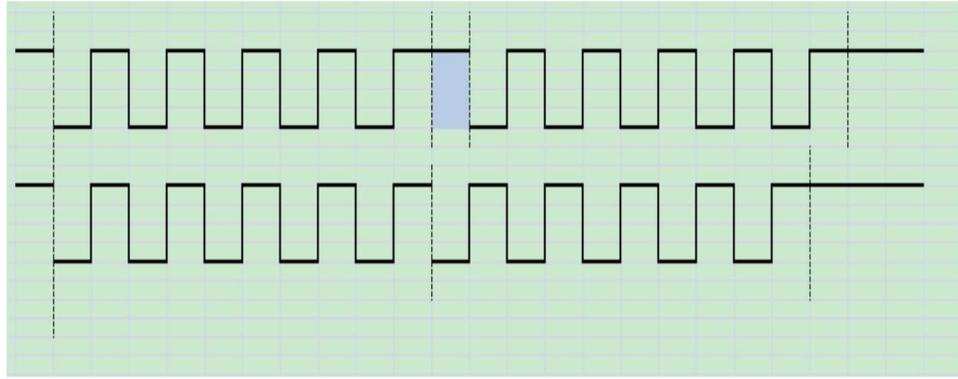
Fig. 1.2

There is a bit of idle between byte and byte, when USART send data continuously. As is shown below.

reason	There is idle bit between byte and byte. (Fig 1.2)
solution	There is no effect on common communication. If communication need special demand, please simulate USART in software.
type	GD32F10x series
tips	Other series without this question
