**GigaDevice Semiconductor Inc.**

**Device limitations of GD32F45x/F40x**

**Errata Sheet**

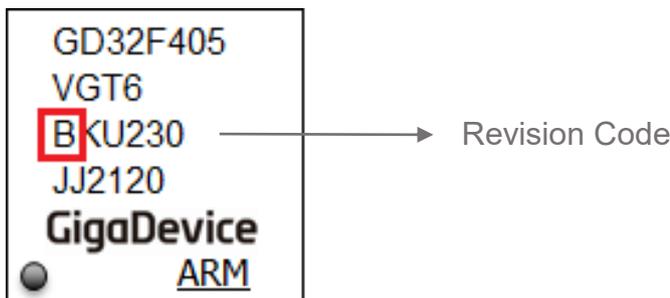
**Figure 1-1. Device revision code of GD32F45x/F40x**

The device revision can be determined by the mark on the top of the package. The 1st code on the line 3 of the mark represents product revision code. As the picture shown in [Figure 1-1. Device revision code of GD32F45x/F40x](#).
